UNDERWATER BRIDGE INSPECTION REPORT

STRUCTURE NO. 90907

SOUTH BRANCH OF THE BUFFALO RIVER

JOB NO. 3512 (CEI 52)

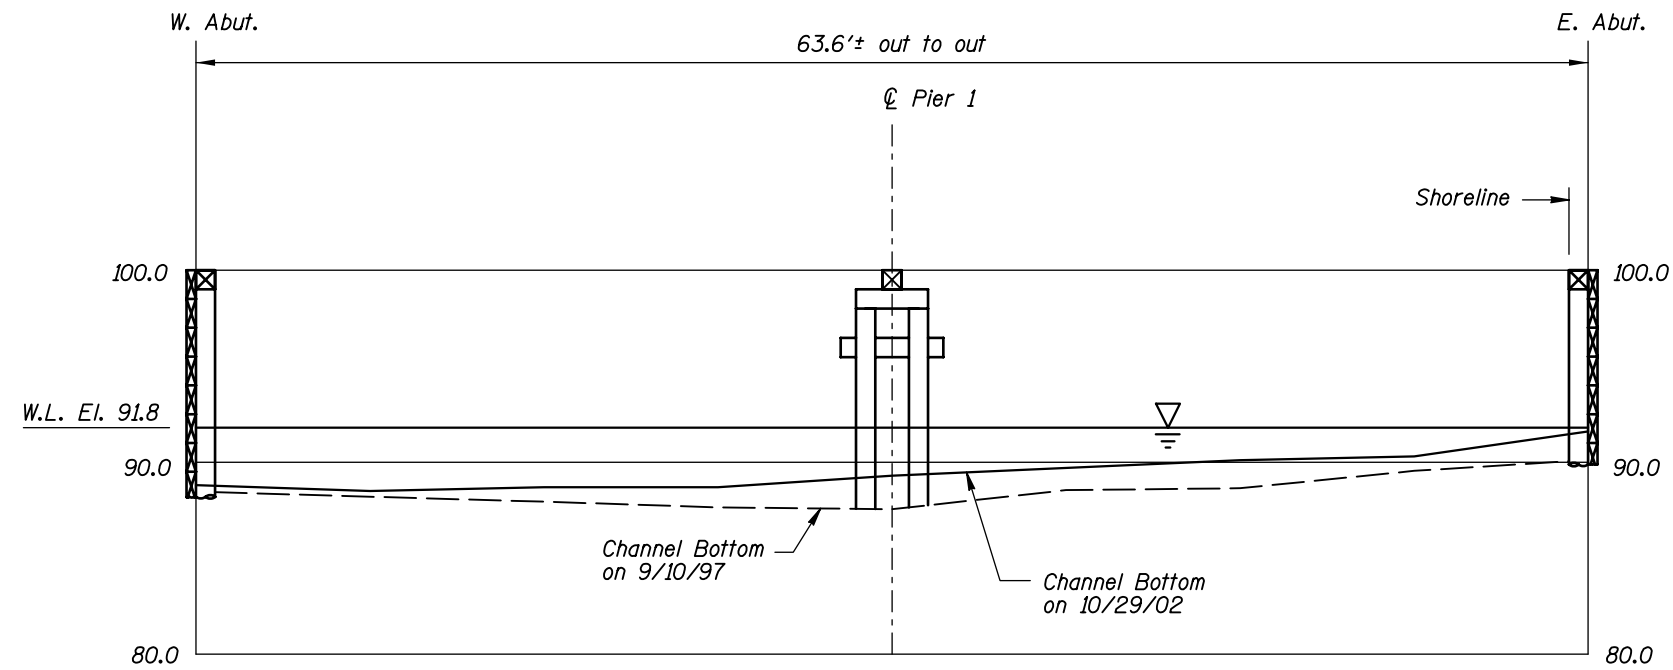
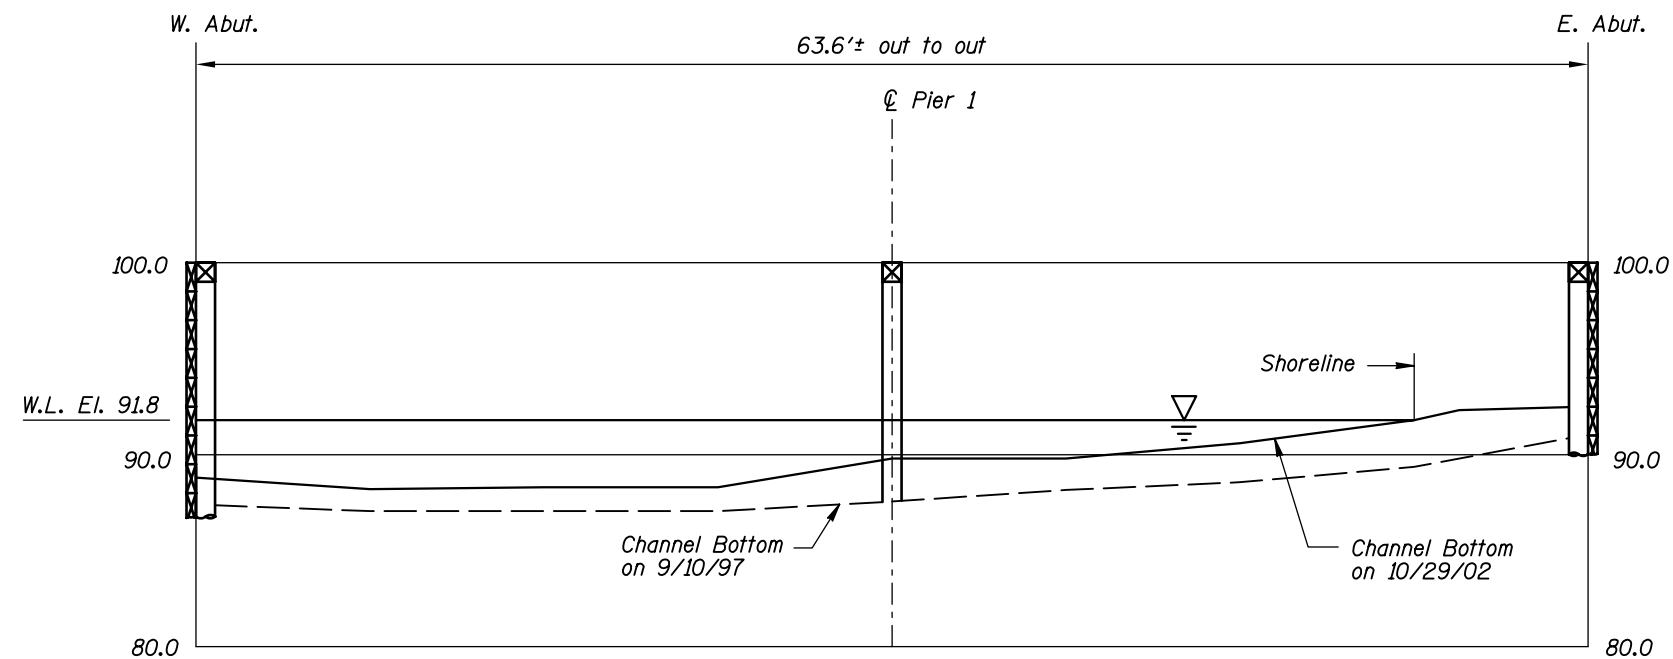
MINNESOTA DEPARTMENT OF TRANSPORTATION UNDERWATER BRIDGE INSPECTION		
STRUCTURE NO. 90907 OVER THE SOUTH BRANCH OF THE BUFFALO RIVER DISTRICT 4, CLAY COUNTY		
UPSTREAM AND DOWNSTREAM FASCIA PROFILES		
Drawn By: PRH	COLLINS ENGINEERS, INC.

UPSTREAM FASCIA PROFILE
Vertical Scale: 1"=10'-0"

DOWNSTREAM FASCIA PROFILE
Vertical Scale: 1"=10'-0"

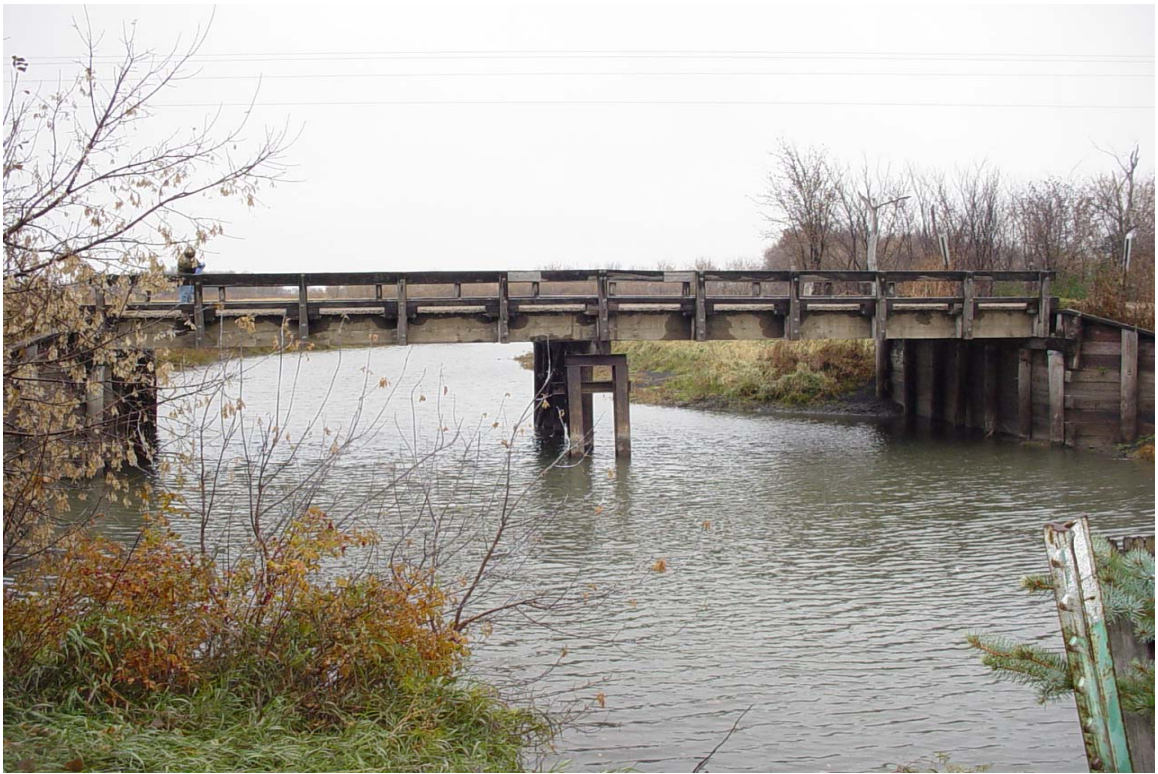
Photograph 1. Overall View of the Structure, Looking Northeast.

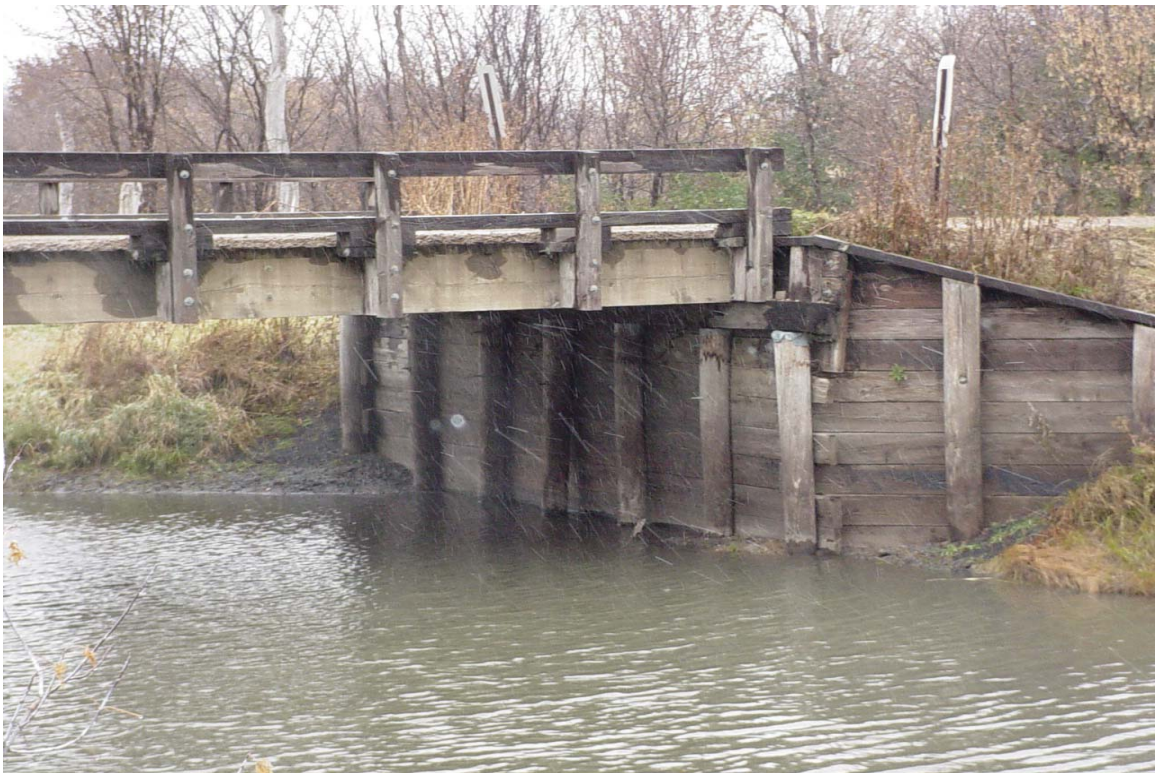
Photograph 2. View of East Abutment, Looking Northeast.

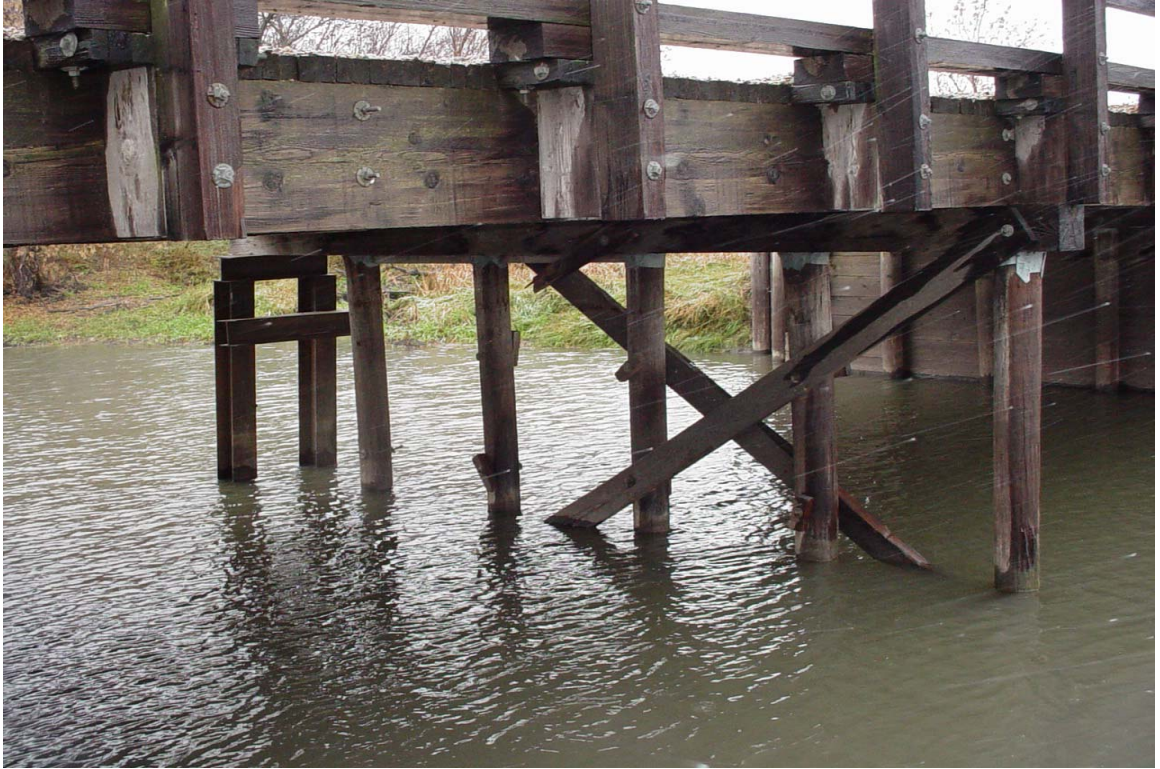
Photograph 3. View of Pier 1, Looking Southwest.

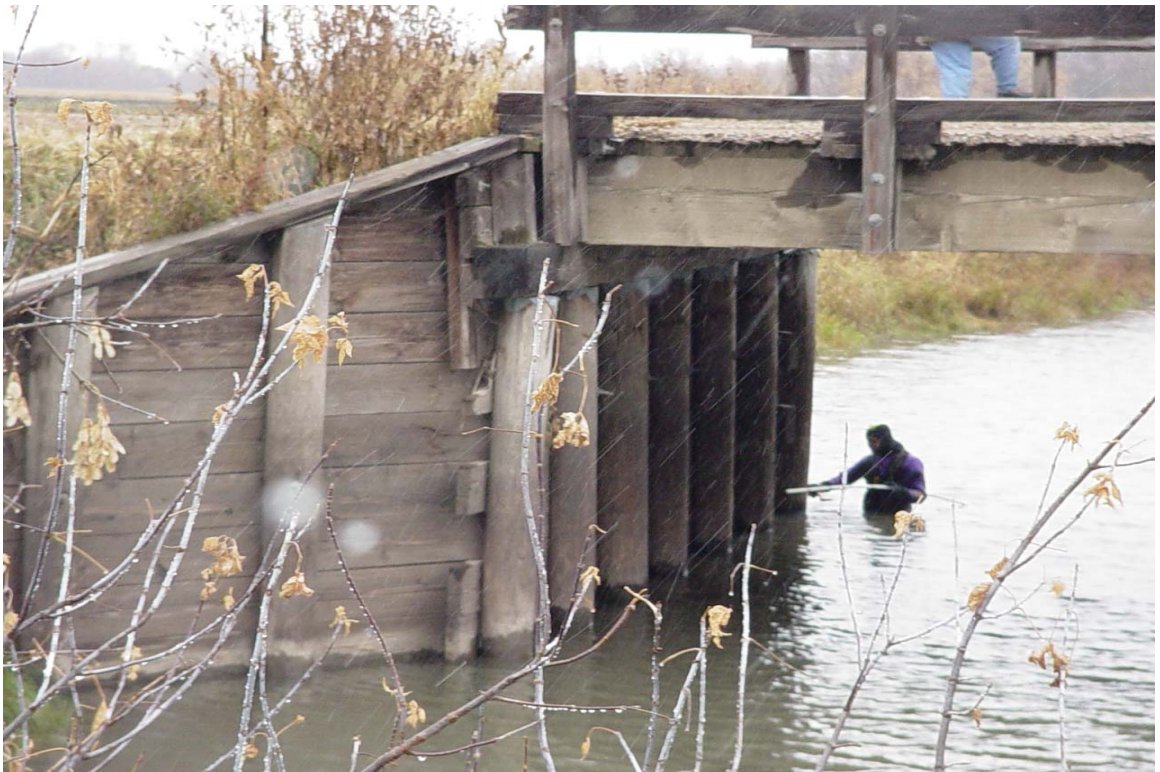
Photograph 4. View of West Abutment, Looking Northwest.
